# Intergranular Cracking in High-Strength, Cold-Rolled, and Precipitation-Hardened Austenitic Stainless Steel UNS S35500

ARL-TR-2133

# **Army Research Laboratory**

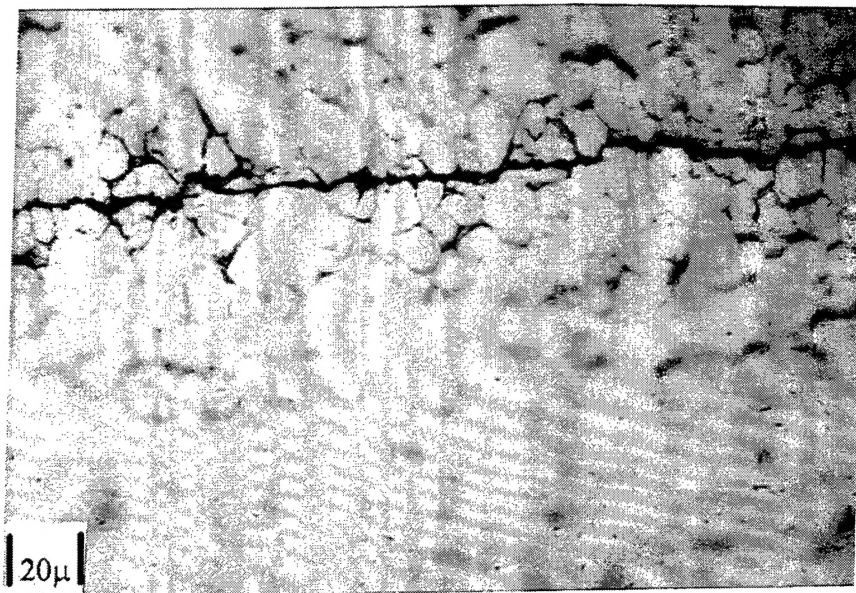
**Figure 1. Fatigue Crack in a UNS S35500 Strap Pack Lamina After 200 hr Service in a Marine Environment.**

Stainless steel UNS S35500, commonly known as AM355 steel, has the composition C 0.12, Cr 15.5, Ni 4.5, Mo 3, and N 0.1%. Quench annealed from 1900° F (1038° C), the steel is soft and almost completely austenitic with small (<5%) amounts of  $\delta$ -ferrite. Heavy cold-rolling will considerably strengthen the steel because of an accompanying martensitic transformation. Further strengthening may be achieved with precipitation of fine carbides during a tempering treatment. Thus, with a 30% cold roll and a 850° F (445° C) temper, the strength is raised from 1030 MPa (150 ksi) to 1510 MPa (220 ksi). At 10% elongation, the cold-rolled and tempered (CRT) material is still very ductile. The carbides precipitate predominantly within and along martensite laths within the previously austenitic grains because of the high energy associated with these regions, and not selectively along austenitic boundaries as might happen in an annealed or mildly work-hardened austenitic stainless steel. Consequently, sensitization due to chromium depletion along grain boundaries is claimed not to be a problem [1]. The combination of high strength, ductility, and good corrosion resistance, due to its 15% chromium content, make this material a good candidate for structural service in military aircraft often used in corrosive marine atmospheres. In one such application, the propeller blades of a helicopter are attached to the rotor shaft via a flexible strap pack assembled from 23–27 laminae of CRT UNS S35500 steel only 0.014 in (0.36 mm) thick. In service, the strap pack experiences high alternating stresses and bending moments and is also exposed to the elements. Fractures of individual laminae have been observed during routine inspections, and one failure has occurred in service. Examinations of the fracture surface of broken laminae showed that the fracture had resulted from fatigue but that the fatigue cracks themselves had possibly started from intergranular cracks. Further, chloride ions were detected at crack origins [2]. Figure 1 shows a fatigue crack observed in a strap-pack lamina after 200 hr of flight time in a marine location.

In the case of the cracking in strap-pack laminae, moisture condensing on laminae in a marine environment would become enriched in chlorides on evaporation of the water. Acidification would occur in pits or crevices [9], creating an environment conducive to intergranular stress corrosion. High residual stresses would already be present in the cold-rolled and tempered laminae of the strap pack. Superimposed on these would be the high stresses in service. The objective of the experimental program was therefore to find out if the intergranular cracking in the field could be reproduced in the laboratory in a chloride solution at potentials possible under aerated conditions. A solution containing 3.5% NaCl was chosen for all experiments. A large body of data exists for behavior of austenitic stainless steels in this solution, and it was thought that the choice of this solution would not only present a representative chloride environment but would also help comparison with results available for pitting and crevice corrosion behavior [10] of more highly alloyed austenitic stainless steels such as UNS S30400 and S31600.

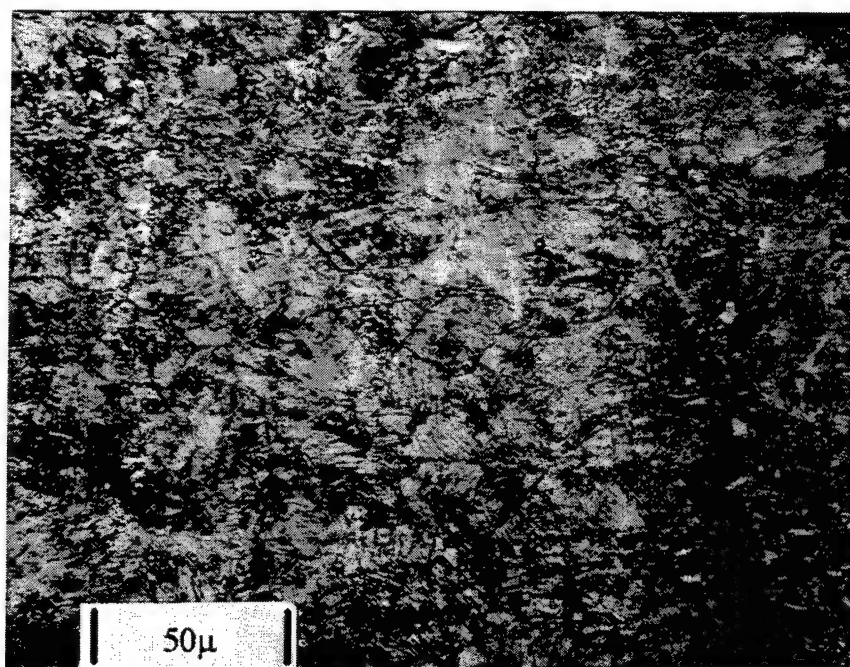
**Figure 2. Microstructure of Cold-Rolled and Tempered UNS S35500 Steel Used for Strap Packs.**

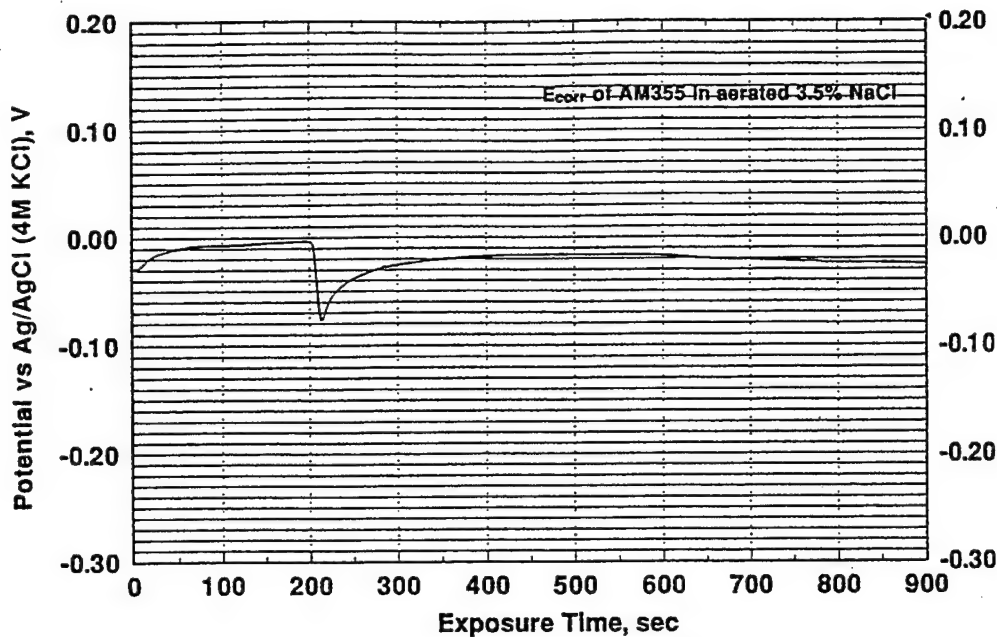
**3.1  $E_{\text{corr}}$  Measurements.** Figure 3 shows a typical  $E_{\text{corr}}$  measurement over a 15-min period. It shows that the potential changed over a range of 80 mV and was, apparently, the result of a dynamic equilibrium between reduction and oxidation reactions over the immersed surface. The sharp transient in  $E_{\text{corr}}$  at about 200 s was apparently caused by the formation of a pit and its repassivation. Similar behavior was observed for all 12 samples taken from different laminae. However, the range of values over which  $E_{\text{corr}}$  changed over a 15-min period was different, even when samples came from different parts of a single lamina and had, presumably, seen the same processing and life history. The lowest  $E_{\text{corr}}$  value was -0.283 V and the highest, 0.092 V. On the basis of these results, it was concluded that the value of 0.1 V was the most positive that this steel might attain in aerated 3.5% NaCl solution, and all stress corrosion tests were done at an applied potential of 0.1 V.

Figure 3. Typical  $E_{\text{corr}}$  vs. Time Change for UNS S35500 in Aerated 3.5% NaCl.

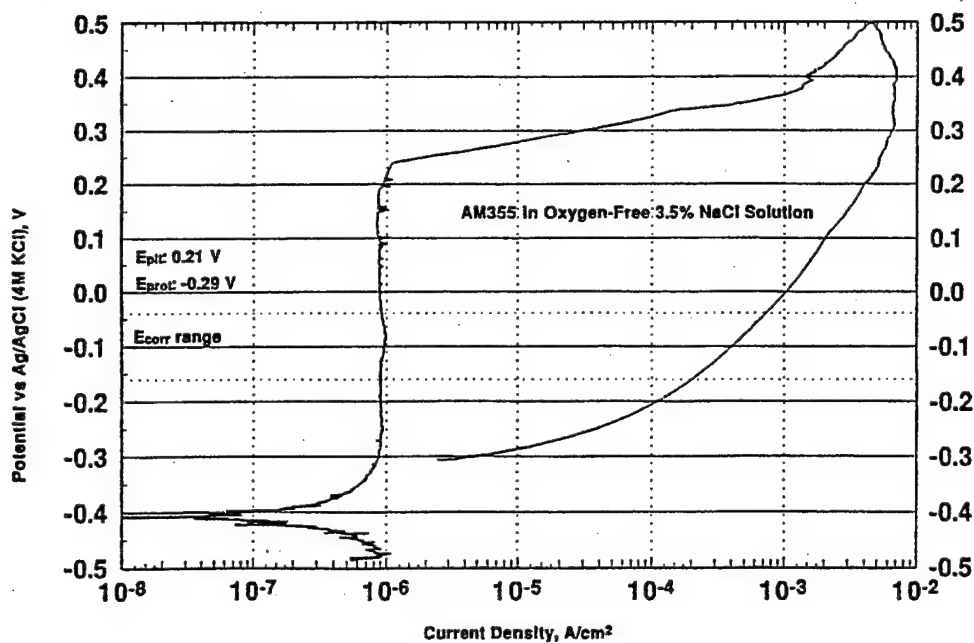
**3.2 Potentiodynamic Polarization Measurements.** Figure 4 shows a typical polarization curve obtained in deaerated 3.5% NaCl on a specimen cut from a strap-pack lamina. It is seen that pitting did not begin until a potential of 0.24 V was reached, and that the protection potential,  $E_{\text{prot}}$ , was -0.29 V. The figure also shows the  $E_{\text{corr}}$  range, -0.16 to -0.04 V, measured in aerated solution for the same sample. It is seen that the  $E_{\text{corr}}$  range was well above  $E_{\text{prot}}$ . As in the case of the  $E_{\text{corr}}$  measurements, the polarization plots were similar for all 12 different specimens, but the pitting potential value varied over a wide range, 0.01 to 0.46 V, even for samples that came from different areas of the same strap-pack lamina. The  $E_{\text{prot}}$  range was, on the other hand, narrower, -0.16 to -0.29 V. In all cases,  $E_{\text{corr}}$  values measured on the same sample in aerated solution were more than 0.1 V more positive than  $E_{\text{prot}}$ , indicating a strong likelihood of pitting and crevice corrosion.

Figure 4. Typical Polarization Curve Obtained on S35500 Strap-Pack Steel in Deaerated 3.5% NaCl.

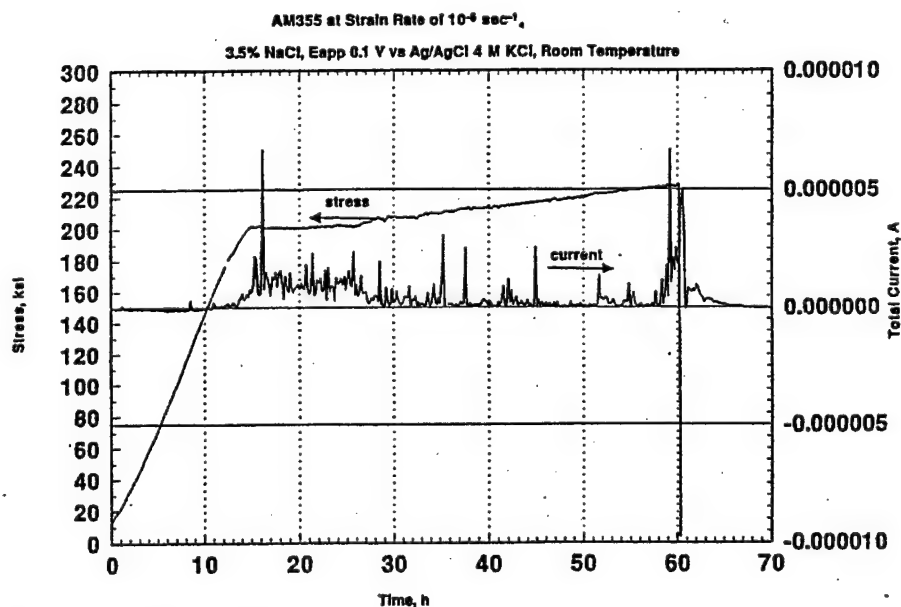
**3.3 Stress Corrosion Cracking Experiments.** No cracking was observed on uncreviced specimens tested in the freely corroding state or at applied potentials of 0.05 or 0.1 V, the only two applied-potential conditions tested. Figure 5 shows change in stress and total current with

Figure 5. Stress and Current in Slow-Strain-Rate Test on Cold-Rolled and Tempered S35500 Steel in 3.5% NaCl at 0.1 V and 10<sup>-6</sup> s<sup>-1</sup>.

time at 0.1 V applied potential in the absence of a crevice. There was no cracking, and the specimen had an elongation of 15%, tensile strength of 1524 MPa (222 ksi), and yield strength of 1373 MPa (200 ksi). These values were similar to those obtained in an air test. The current was anodic but small ( $<5 \times 10^{-7}$  A/cm<sup>2</sup>) over most of the test, indicating that the test material was in a passivated condition. The lack of cracking was confirmed by the ductile nature of the fracture surface, as revealed in microscopic examination.

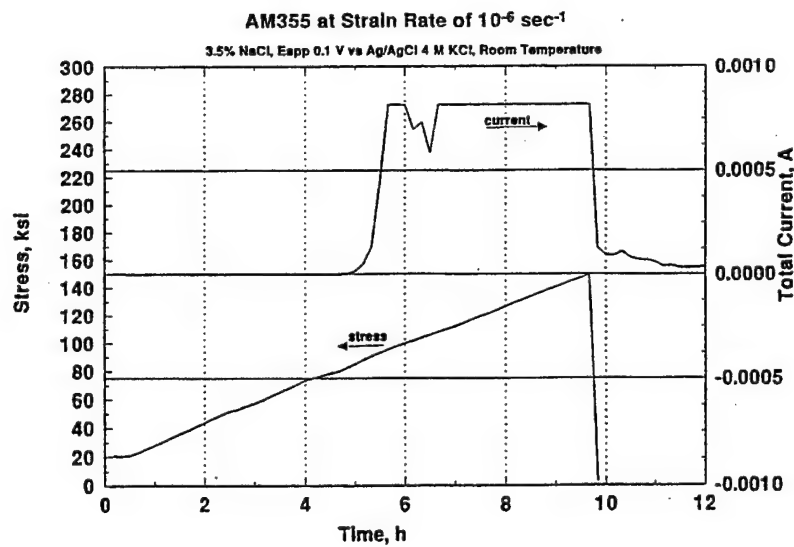
However, cracking occurred under these conditions if crevice conditions were created on the specimen surface by placing an artificial crevice-former on the specimen surface. Data from one such test are shown in Figure 6. It is seen that time to failure decreased from 60 hr without crevices to less than 10 hr with crevices and the maximum stress sustained was only 1030 MPa (150 ksi), well below the yield strength of the material. The data also show that the total current increased sharply at 5 hr and stayed at a relatively high 0.75 mA until fracture occurred. At the moment of fracture, the current dropped sharply, to ~0.15 mA, but continued to be anodic and at a level higher than the current before the onset of cracking. During cracking, new intergranular material is being exposed to the solution. When cracking has progressed to such an extent that the load borne by the intact segment exceeds the strength of the material, this remaining material fails in a ductile mode. The resulting fracture surface is therefore a mixture of intergranular and ductile, dimpled fracture. The large current during cracking suggests that the intergranular regions being dissolved are chemically much more active to the changed solution chemistry in the crevice than the ductile-cum-intergranular fracture surfaces exposed to the same solution after complete fracture. Secondary cracks were not observed.

**Figure 6. Stress and Current in Slow-Strain-Rate Test on Cold-Rolled and Tempered S35500 Steel in 3.5% NaCl at 0.1 V and  $10^{-6} \text{ s}^{-1}$  With an Artificial Crevice on the Gauge Surface.**

In this test, judging from the change in current (Figure 6) cracking seems to have begun when the stress was ~80 ksi in the fifth hour of straining (the straining would have otherwise proceeded for a total of ~60 hr had SCC not occurred). The stress level at which cracking started was different for a total of five tests in which cracking occurred under crevice and ranged from 150 to 230 ksi. The corresponding time to failure ranged from 9.8–19.2 hr.

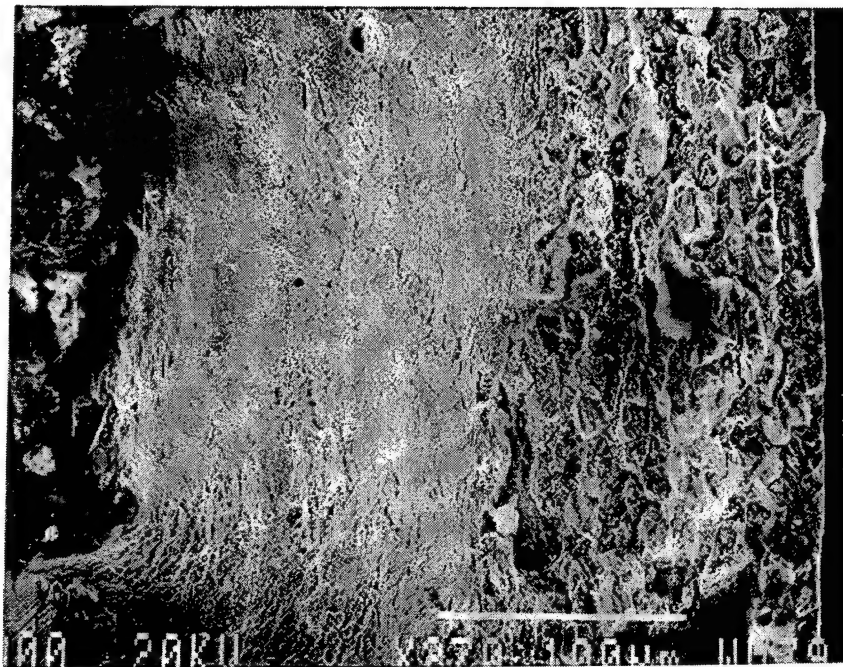
Part of a fracture surface showing its intergranular and dimpled areas is shown in Figure 7. In the picture, intergranularly fractured areas flank an area of dimpled fracture. Further, one of the two intergranular areas shows greater corrosion damage, showing that: (1) the fracture here occurred earlier in time, and (2) the solution to which it was exposed was more corrosive to bulk metal than the bulk solution.

**Figure 7. Mixed Fracture Surface of S35500 Specimen Tested With Artificial Crevice at 0.1 V and  $10^{-6} \text{ s}^{-1}$ .**

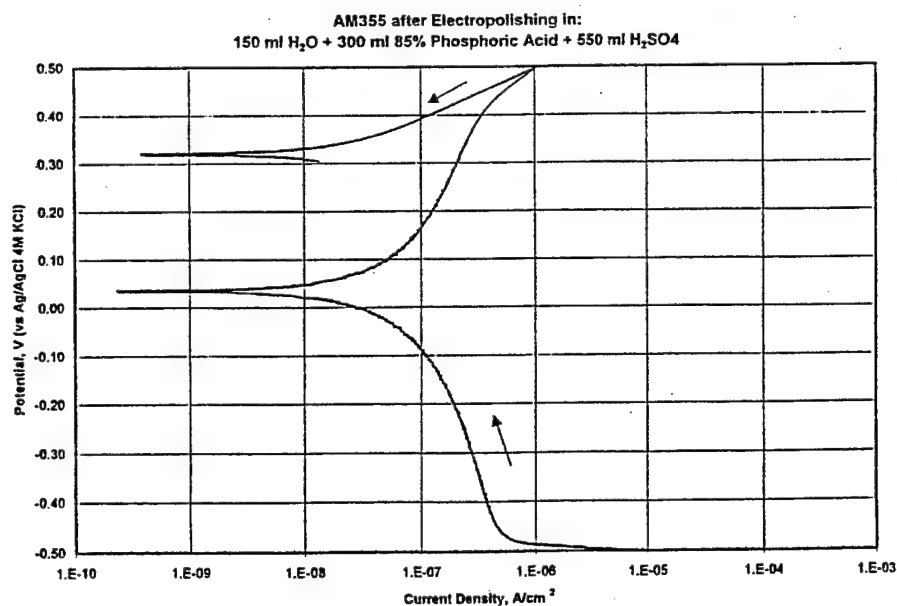
**3.4.1 Polarization Behavior.** Electropolishing improved the corrosion performance of S35500 steel in 3.5% NaCl. However, the improvement did not occur until at least the top 0.5 mil (13  $\mu\text{m}$ ) of material had been removed. It is likely that repeated heating during processing of the CRT material in the manufacture of laminar material results in chromium depletion at the surface, as is known [19] to occur in the case of 18-8 type stainless steels. Apparently, this outer, chromium-depleted material needed to be removed in electropolishing before its corrosion performance could improve. Removal, in electropolishing or pickling, of nonmetallic inclusions, especially sulfide inclusions, has also been shown [20] to lead to an improved pitting resistance in stainless steels. Figure 8 is a polarization curve obtained in deaerated 3.5% NaCl on electropolished steel. It is seen that any hysteresis in current that would indicate pitting is absent. When material that was both electropolished and overpassivated was to a similar cyclic potentiodynamic polarization (data not presented graphically in this report), hysteresis was again absent,  $E_{\text{corr}}$  was more noble (0.33 V vs. 0.04 V in Figure 8), and both anodic and cathodic branches were displaced to the left and lower current densities. Thus the electropolished and overpassivated material was even more resistant to pitting than material that was only electropolished.

**Figure 8. Polarization Curve for Electropolished S35500 Strap Pack Steel in Deaerated 3.5% NaCl.**

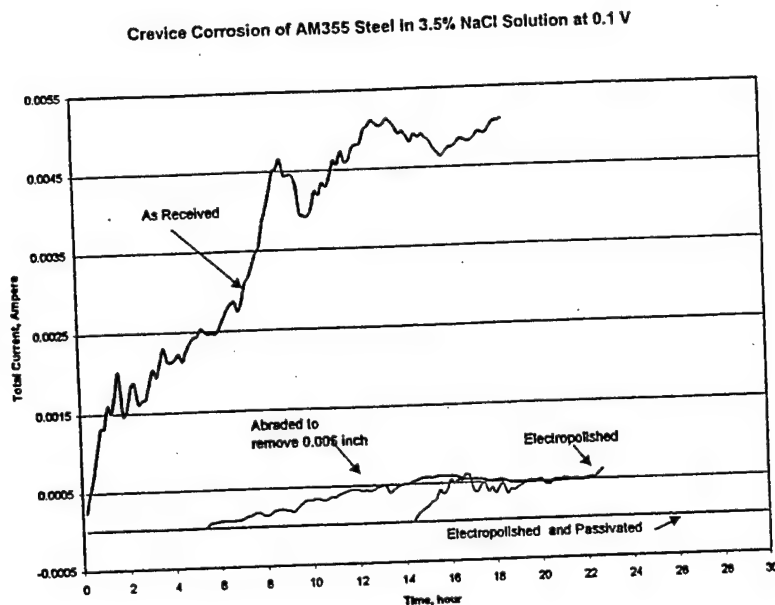
The change in current with time for crevice assemblies with these four different types of surface treatments is shown in Figure 9. The current under the crevice assembly increased in a seemingly runaway manner for the as-received material. Examination of the specimen after a 20-hr test showed heavy attack under the crevice. On the other hand, current for electropolished and passivated material showed no increase over a nearly negligible passivation current ( $<1 \times 10^{-7}$  A) for 30 hr and continued to do so for a total of 300 hr of test (data not shown in Figure 9). Intermediate behavior was observed in only abraded and only electropolished materials. These latter materials showed an increase in current after the 5th and 14th hr, respectively, but to a much lower final total current of  $5 \times 10^{-4}$  A, vs. 0.005 A for the as-received material. Examination of these latter specimens after a 23-hr test showed only pits under the artificial crevices—not heavy crevice corrosion. It is thus seen that electropolishing combined with overpassivation led to a considerable improvement in the pitting and crevice corrosion resistance of CRT S35500 steel.

**Figure 9. Current for Creviced, S35500 Strap Pack Steel at 0.1 V in Deaerated 3.5% NaCl for Different Surface Conditions.**

crevice corrosion in chloride solutions. In Figure 9, the current is small even after pitting had been initiated for abraded or electropolished samples. On the contrary, current was increasingly large for the as-received sample once crevice corrosion had been initiated. These results show that pits on this material in chloride solution may get repassivated and stop growing, but crevice corrosion, having once begun, continues at an increasing rate. Once crevice corrosion has begun, consequent and ever-increasing acidification of the crevice solution [21] eventually causes stress corrosion cracking in the presence of sufficiently high tensile stresses. The third requirement, that of a structure susceptible to SCC, is apparently satisfied: S35500 steel in the CRT condition seems to have a sensitized structure similar to the one occurring in sensitized, higher-alloy, austenitic stainless steels. The tempering treatment is, after all, conducted for the purpose of carbide precipitation. The tempering temperature, 850° F (445° C), is below the range, 950–1450° F (510–788° C), in which sensitization of austenitic stainless steel is generally considered [21] to occur. So, slow diffusion of chromium, which leads to chromium depletion in the vicinity of carbides in a sensitized stainless steel, will be even more of a sensitization factor in the case of the present material.

The improved corrosion resistance of electropolished material from overpassivation (Figure 9) is striking. Improvements from such surface treatments have been dismissed as [22] artifacts. However, the improvement in pitting and corrosion resistance in Figure 9 was no "artifact." The improvement was verified in multiple tests using different acids for

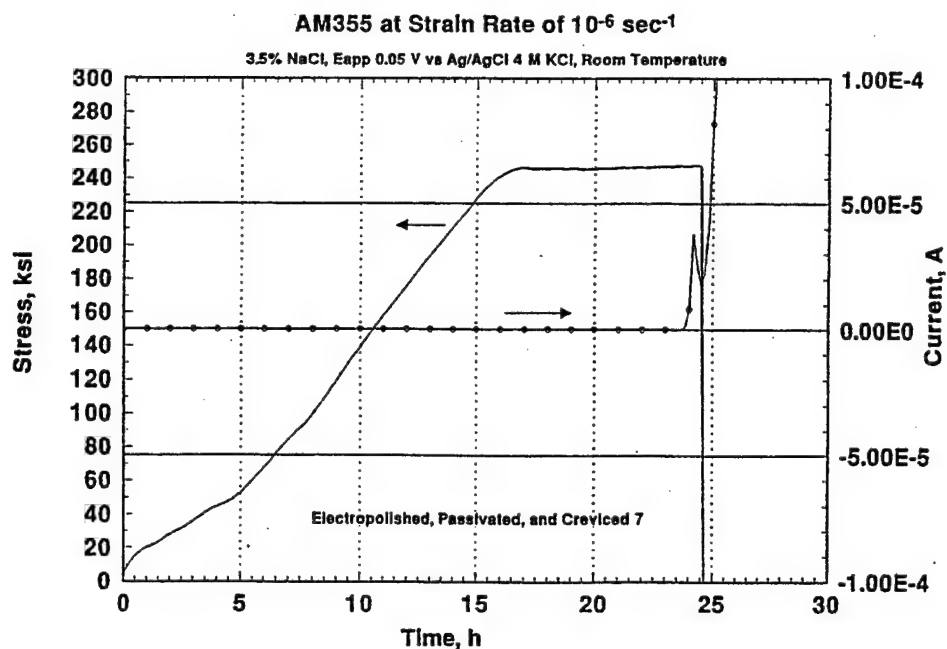
**3.4.3 Stress Corrosion Cracking.** Figure 10 shows change in stress and current when an electropolished, overpassivated, and creviced specimen was strained at 0.1 V in a slow-strain-rate test. Premature failure by intergranular cracking did occur, but the time to failure, 24.5 hr, was longer and the maximum stress sustained, 250 ksi, was much higher than when as-received material was strained under similar conditions. Figure 11 is a scanning and electron microscope (SEM) photograph of the crack origin in the crevice area showing both the fracture surface and the free surface near the crack origin. It shows cracks originating from an area of crevice corrosion on the specimen surface. These results, Figures 10 and 11, show that in an electropolished and overpassivated condition, the material was resistant, but not immune, to chloride cracking under crevice conditions.

**Figure 10. Data for Slow-Strain-Rate Test of Electropolished, Creviced Specimen Held at 0.1 V in 3.5% NaCl.**

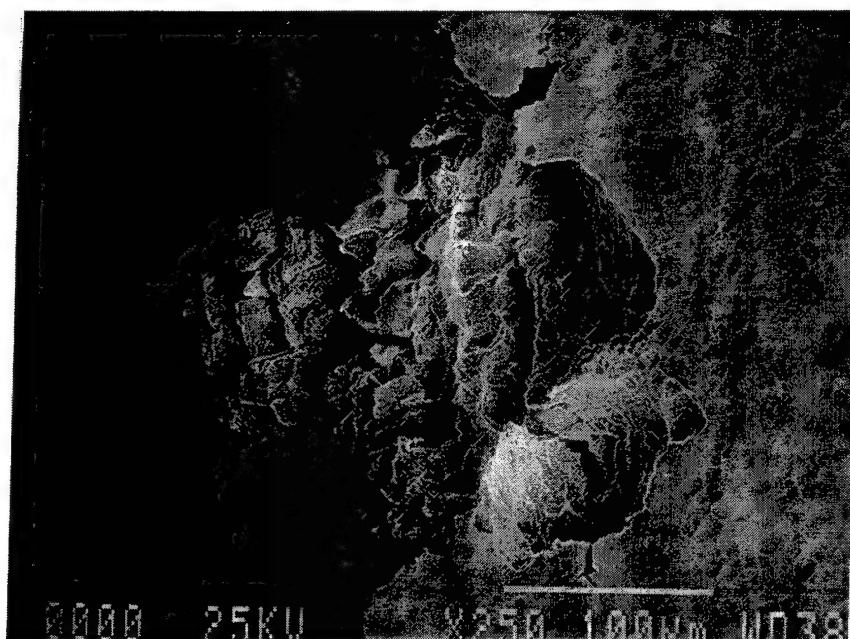
**Figure 11. SEM Photograph of the Origin of Intergranular Stress Corrosion Cracking in an Electropolished and Overpassivated Specimen in a Slow-Strain-Rate Test.**
